Case Study: White Etching Cracks and the Danger of an Improperly Performed Oil Change

Hagen Elgeti January 2021

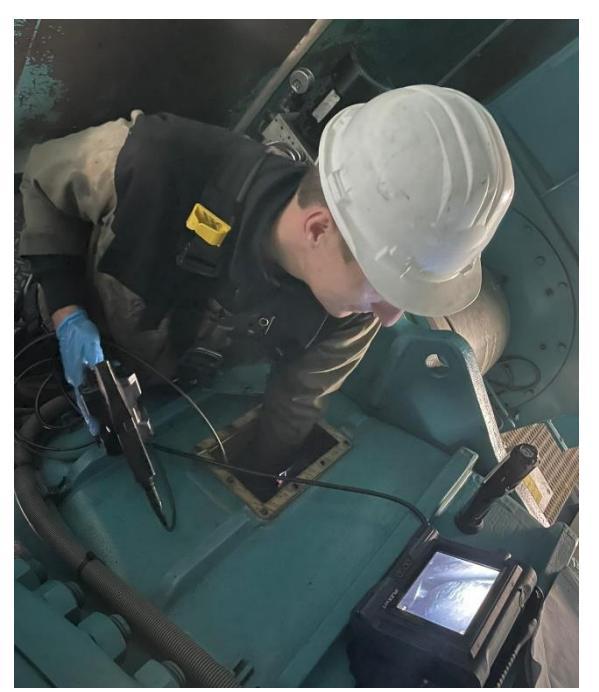
During a routine inspection on the gearbox in question, endoscopy discovered significant damages to one of the bearings in the wind energy converter. Excessive foaming was also observed in the oil and a sample was taken for later analysis. The damaged bearing was removed and sent to Elgeti Engineering's laboratory for further analysis. Two different damage modes were evident in the visual inspection and a sample was taken for material analysis. The subsequent examination of the microstructure in

Figure 1: On-site inspection of the gearbox with endoscopy

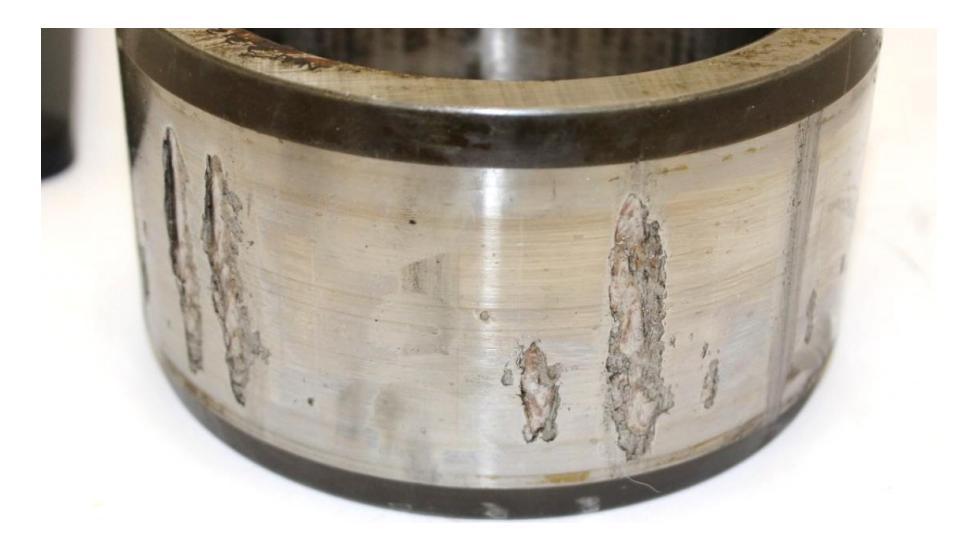
After documenting its condition upon arrival, the bearing was disassembled and cleaned. Multiple damages were present on the inner ring (Figure 2) while the outer ring had only a single point of damage (Figure 3). Both raceways as well as the rollers show signs of rolled over particles that can be considered as secondary damages to the inner ring (Figure 4). The presence of harder particles is also evident in the wear visible on the cage (Figure 5). Frictional wear is visible on both bearing seats, more pronouncedly on the outer ring (Figure 6), but this is unremarkable given the fits typically employed in the application. Aside from oil deposits, there are no further significant findings. Since the marks observed on the other components are clearly secondary, the focus will subsequently be on interpreting the damage to the inner ring.

Figure 2: Some of the damage on the inner ring

The examined bearing failed due to damage on the inner ring caused by a superposition of rolling element fatigue and embrittlement fractures. In this case, the fatigue damages were a consequence of the cracks caused by the embrittled material.

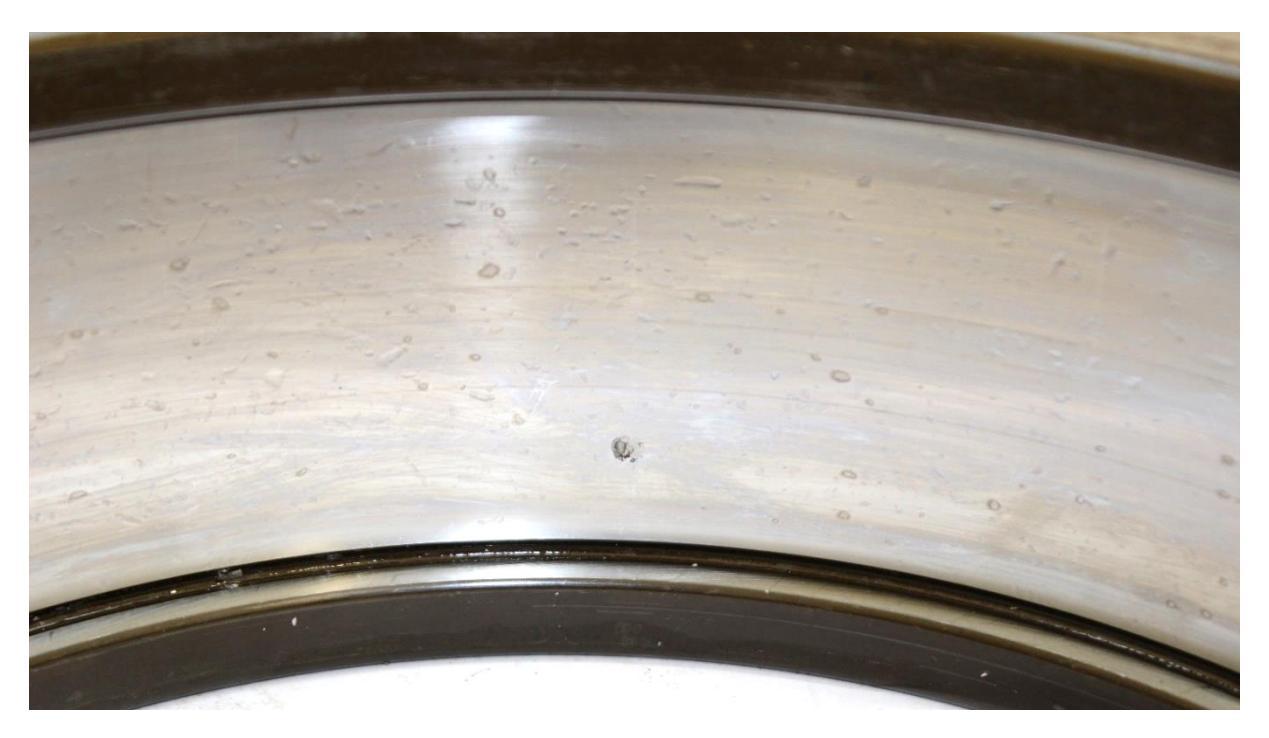
Figure 3: An isolated point of damage on the outer ring

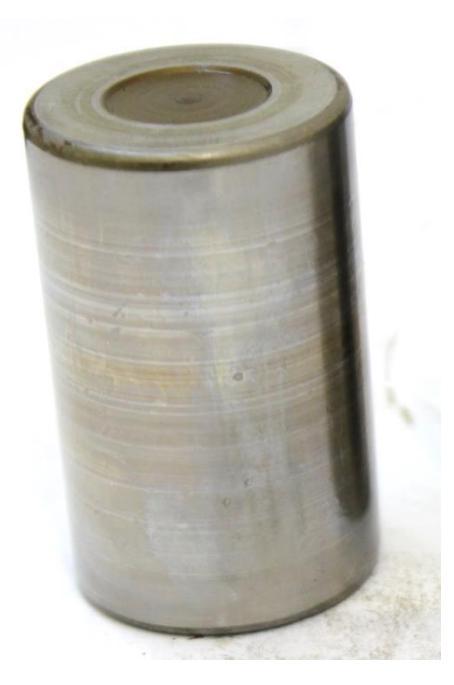
Figure 4: A roller with particle impressions

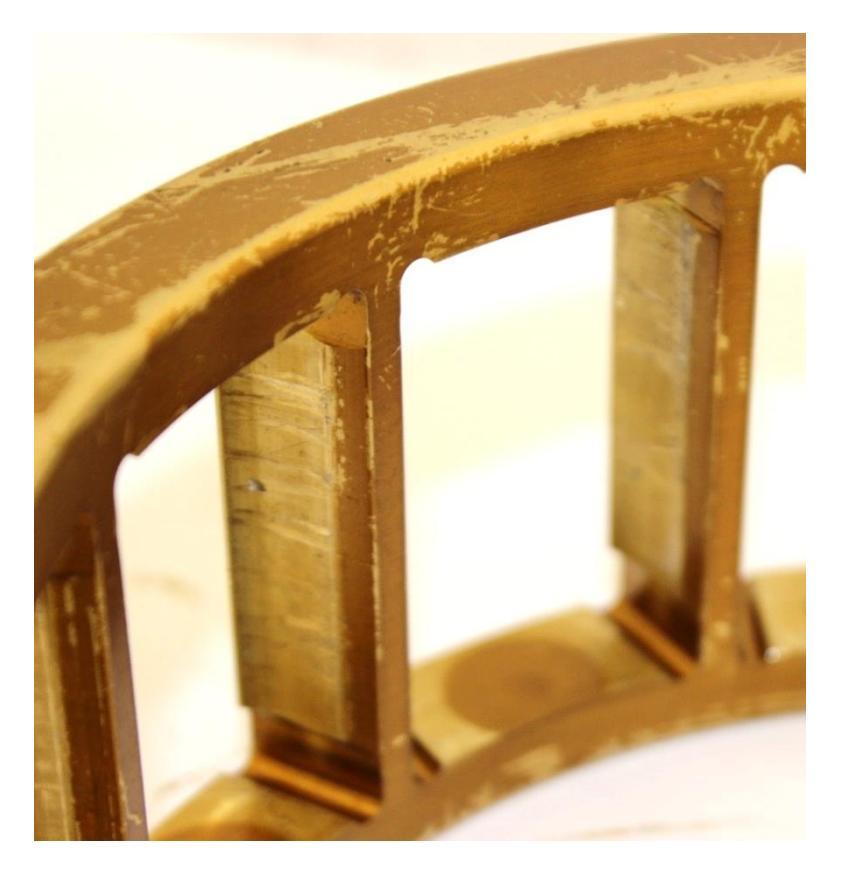
Figure 5: Cage with lubricant deposits and signs of wear from harder particles in the pockets

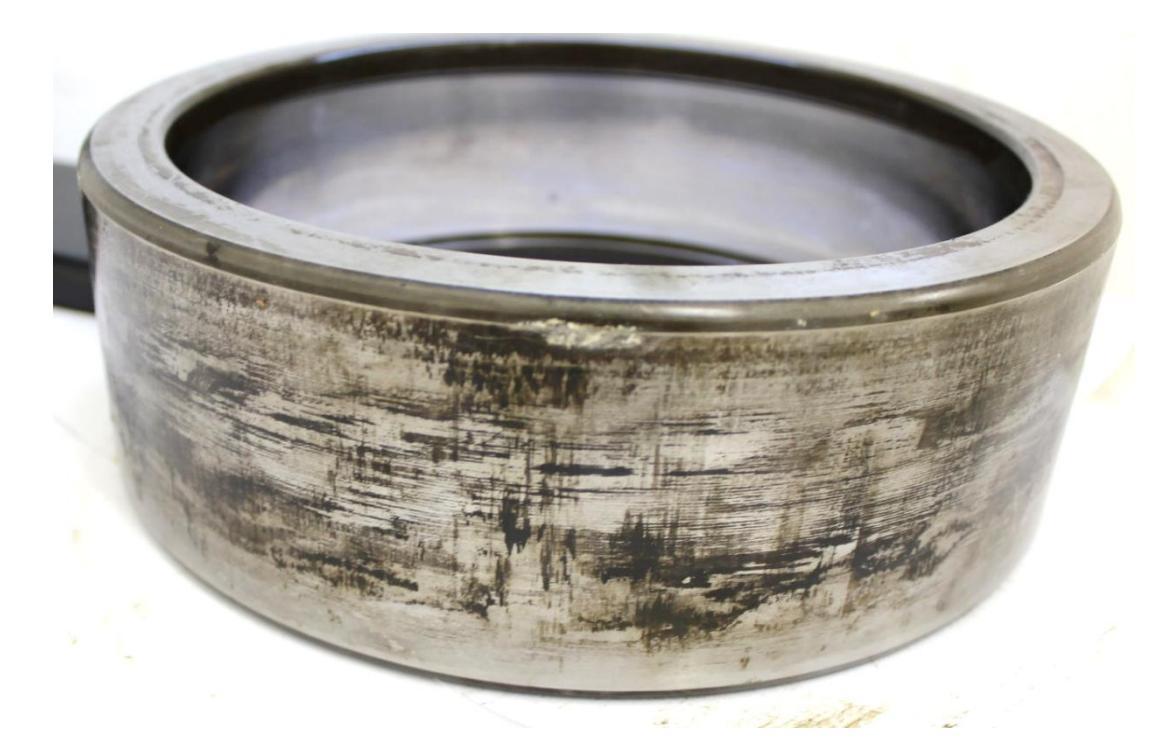
Figure 6: Frictional wear marks on the seat of the outer ring

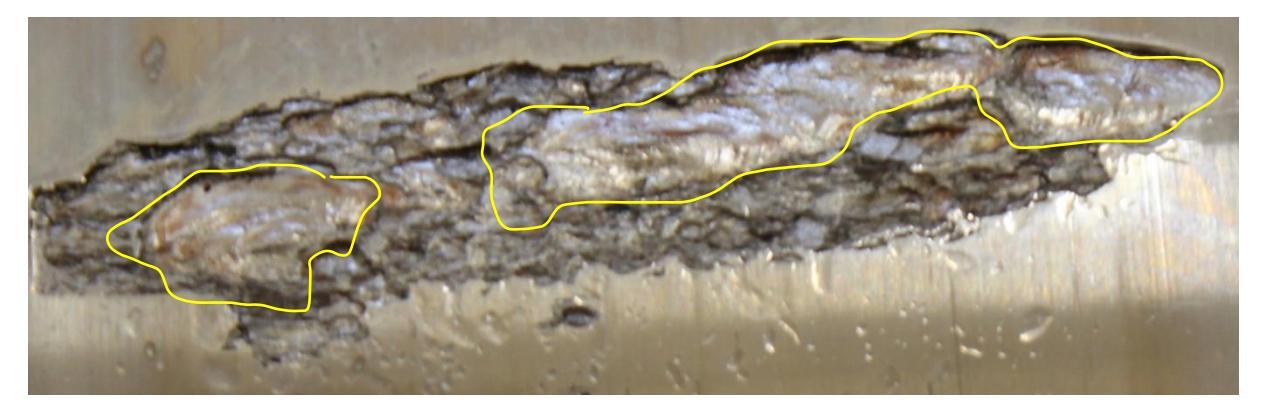
This leaves changes to the microstructure as the only remaining possibility. A close examination of the damaged areas shows two phenomena in superposition: rolling element fatigue that presents as fine flaking, and areas that are flatter and deeper (Figure 8). The latter fractures are characteristic of material embrittlement and it can reasonably be assumed that these areas appeared first and caused the fatigue damages.

Figure 8: Close up of a damaged area showing a combination of fatigue and embrittlement damages (marked in yellow)

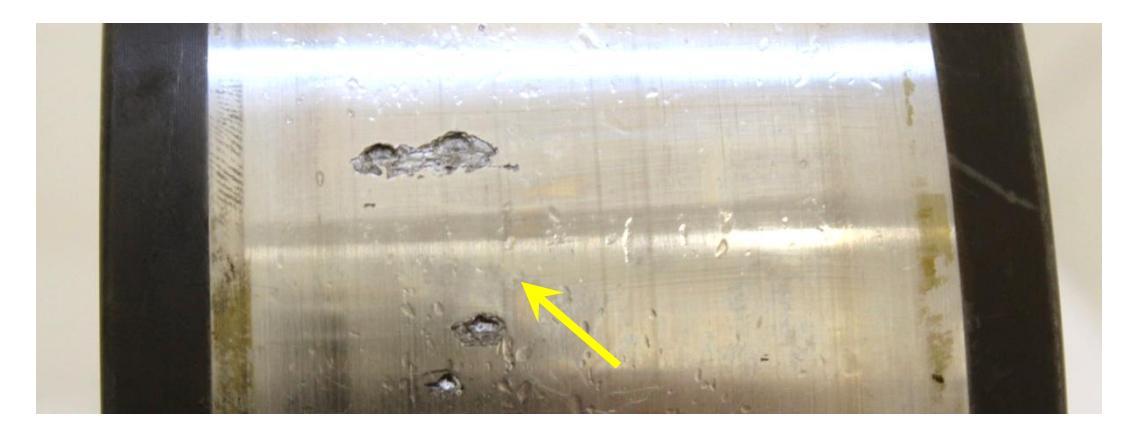
Additionally, the axial cracks emanating from some of the damaged areas (Figure 9) are also typical of material embrittlement; more specifically, these cracks frequently occur in connection with white etching cracks. The primary suspect for the root cause of this embrittlement – and white etching cracks – is the presence of atomic hydrogen, which among other things can developed due to chemical degradation of the lubricant.

Figure 9: An example of an axial crack

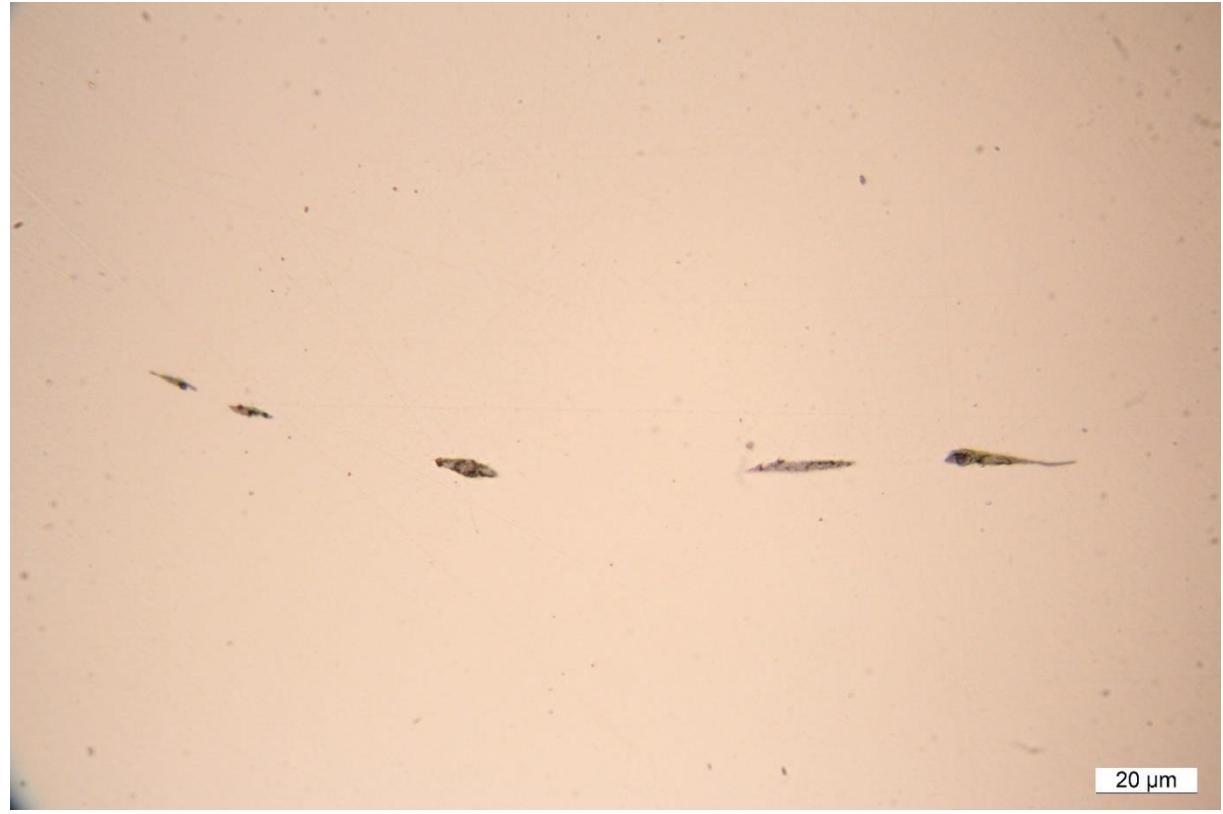
Overall, the cleanliness is good with only a few small inclusions, predominantly elongated manganese sulphide (grey) paired with oxides (black) (Figure 10). This degree of inclusions is completely normal and not of concern. The microstructure itself is very regular and shows that the bearing was made of high-quality steel and appropriately heat treated.

Figure 10: Manganese sulphide inclusions and oxides

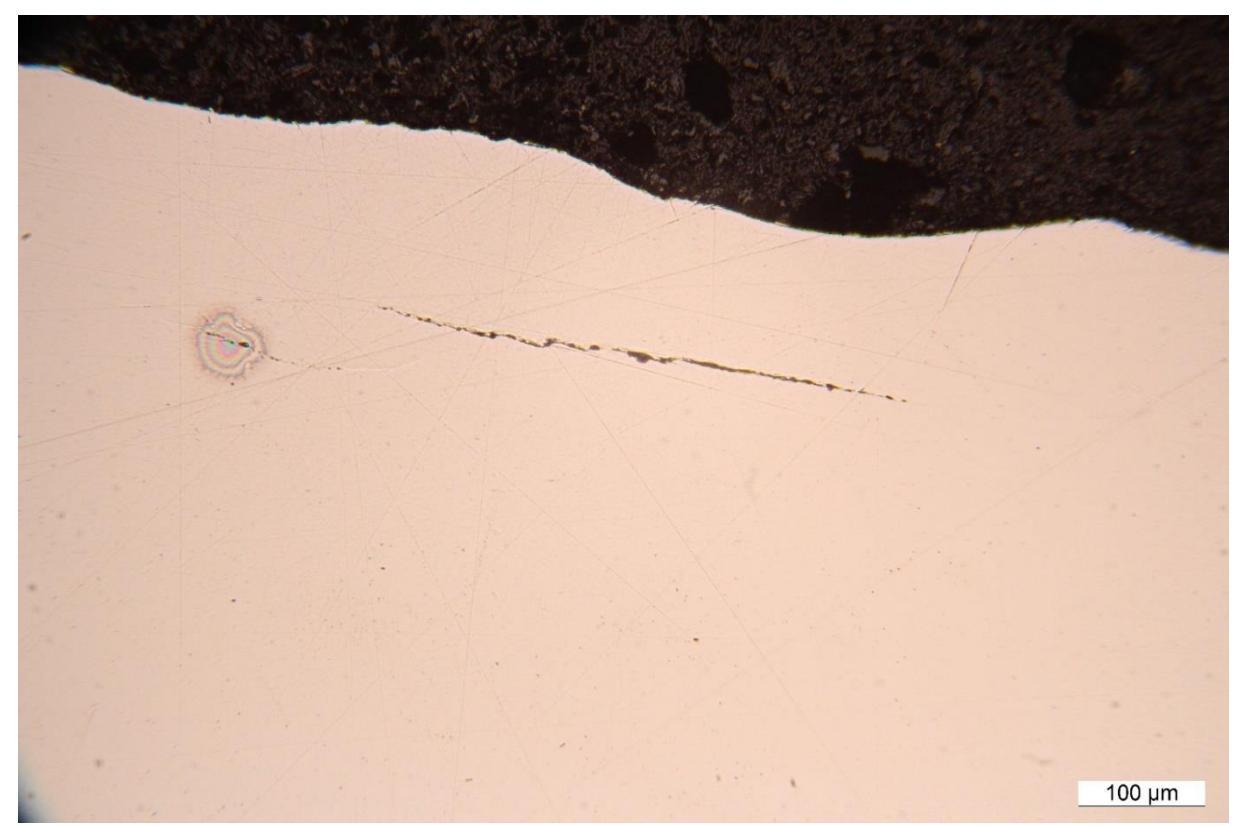
While Figure 11 shows parallel subsurface cracks typical of rolling element fatigue, Figure 12 shows a chaotic crack network that is indicative of embrittlement. Indeed, Figure 13 shows a white etching area visible as a lighter spot in the microstructure. These white etching areas are structural modifications associated with the presence of atomic hydrogen and which lead to a significant weakening of the material. When cracks develop from these areas they are called white etching cracks (Figure 14 and Figure 15).

Figure 11: Subsurface cracks due to rolling element fatigue

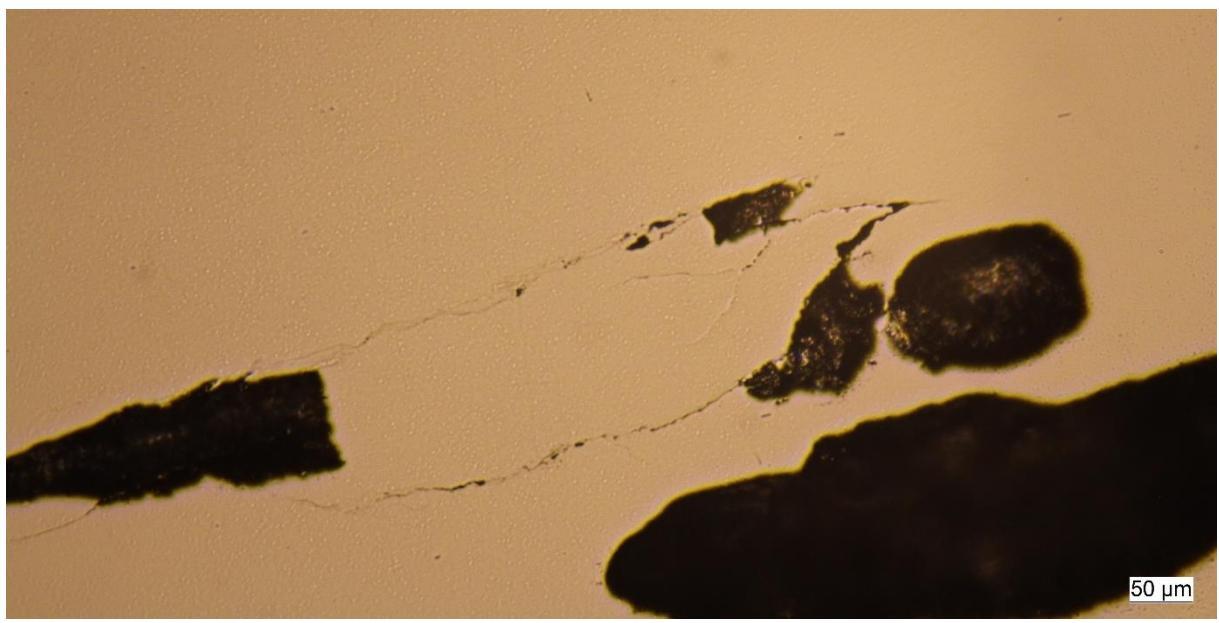
Figure 12: Chaotic crack network typical of embrittled material

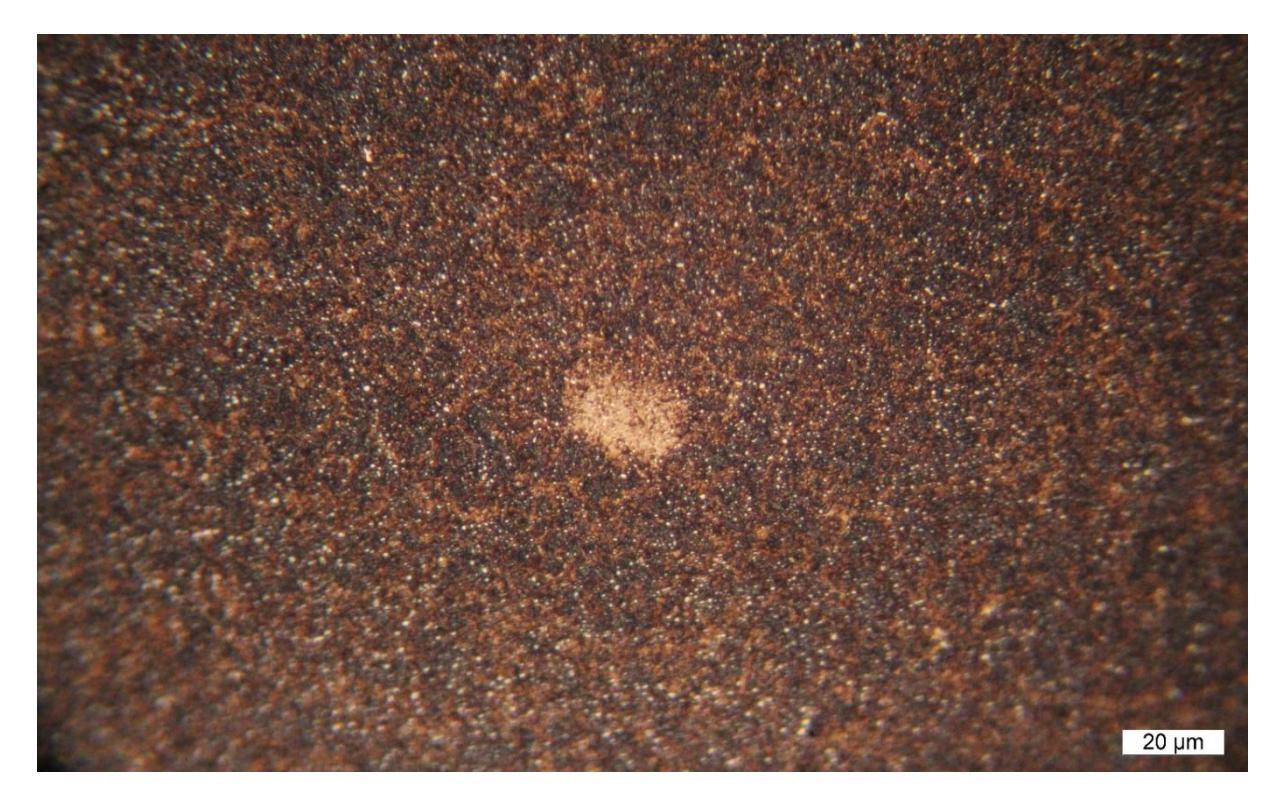
Figure 13: White etching area in an otherwise regular microstructure

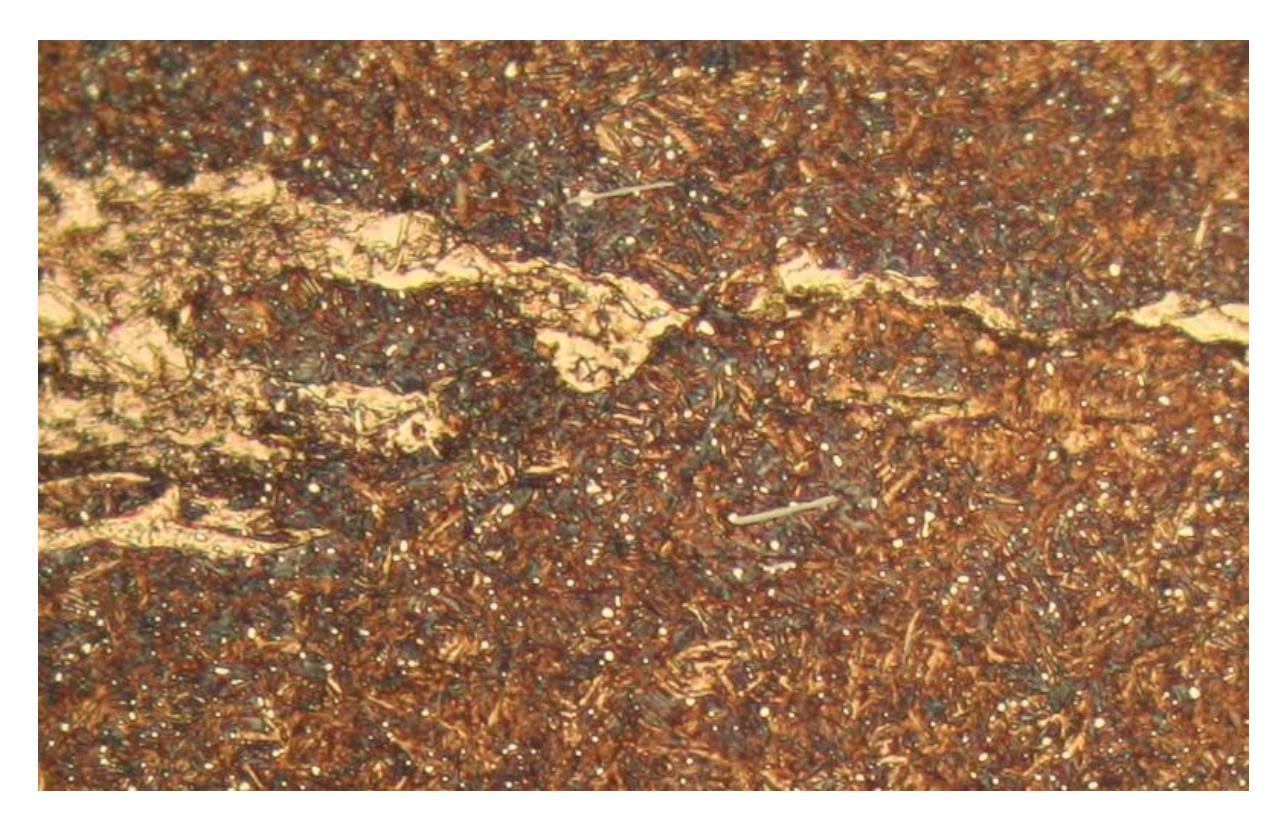
Figure 14: White etching areas

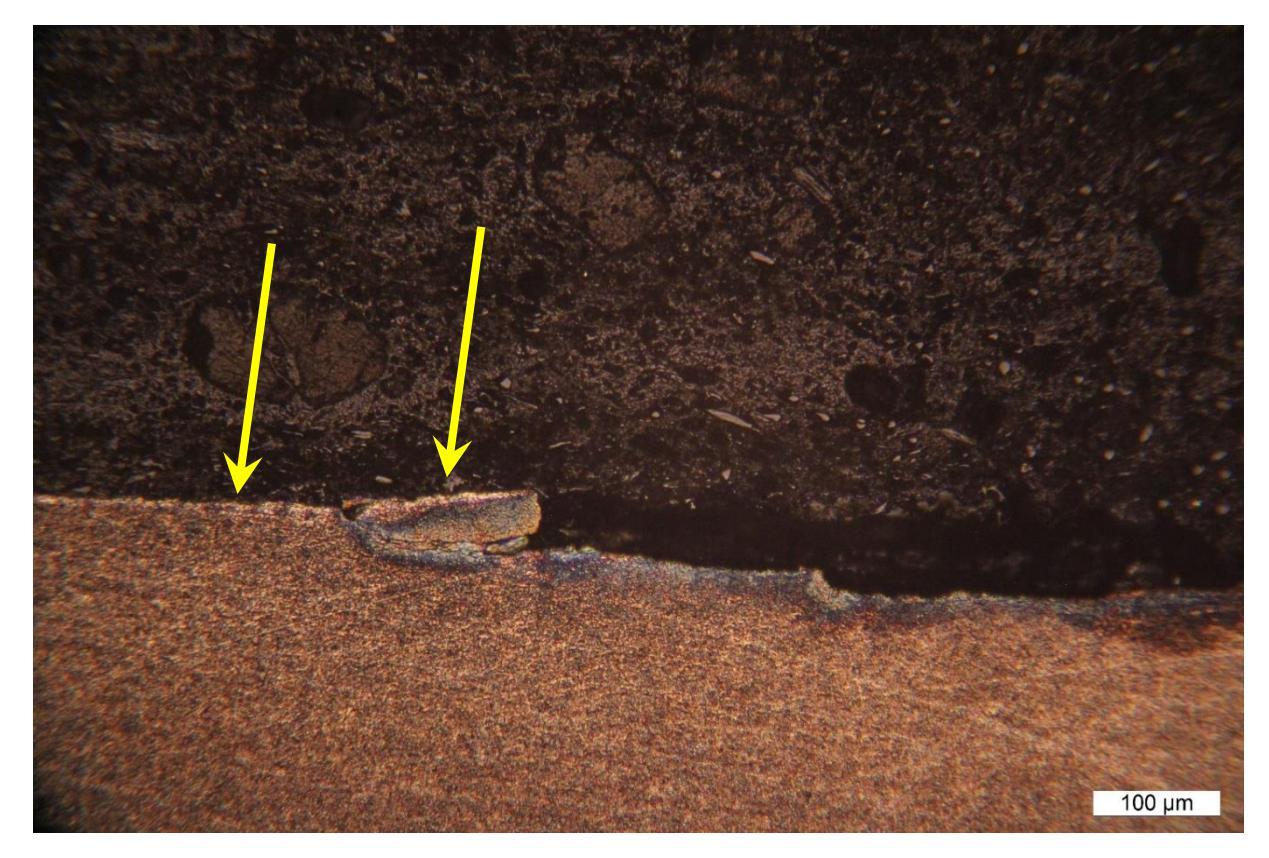
Figure 15: Remnants of white etching areas along a fracture edge
