Case Study: Gearing Damage

Hagen Elgeti September 2021

1 Background

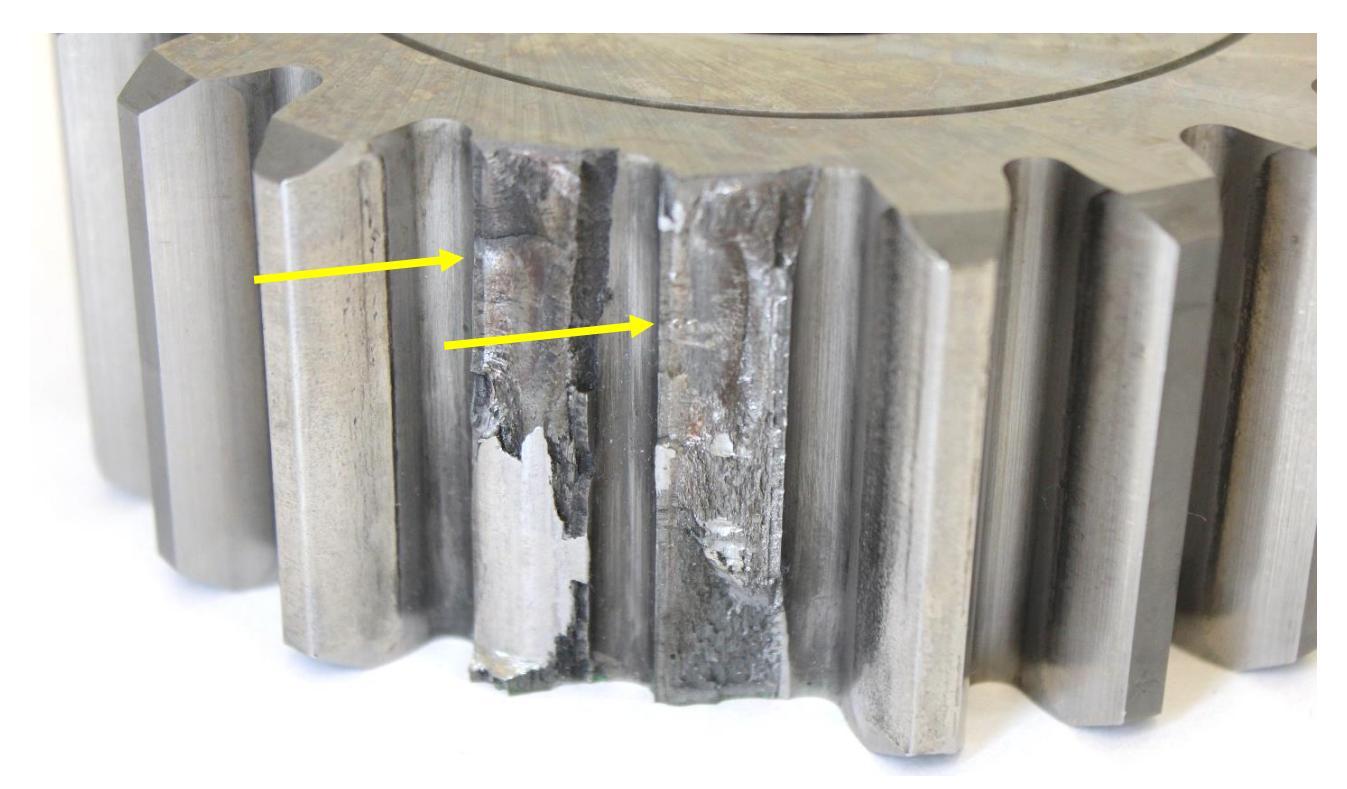
Several damaged gears were received. The most obvious damage was one to two broken teeth due to fatigue fractures. The cracks originated at the bottom of the loaded area of the flank, indicating the presence of high loads. This area of the tooth also experiences the greatest sliding movement which further increased the loads. The point of origin was only slightly eccentric, indicating that no significant misalignment was present (Figure 1). On the undamaged teeth, cracks were also beginning to develop in the same area (Figure 2).

Figure 1: Damaged gear: crack initiation sites and plastic deformation at the edge of the contact areas.

Visual inspection showed the existence of a sharp edge where the pinion modification begins. It can be shown that such edges are likely to multiply the local pressure and failures are therefore likely to begin right where this edge hits the flanks. Subsequently, one must conclude that the failures can be traced back to either improper manufacturing or the lack of a smooth transition between the modified and unmodified flank areas.

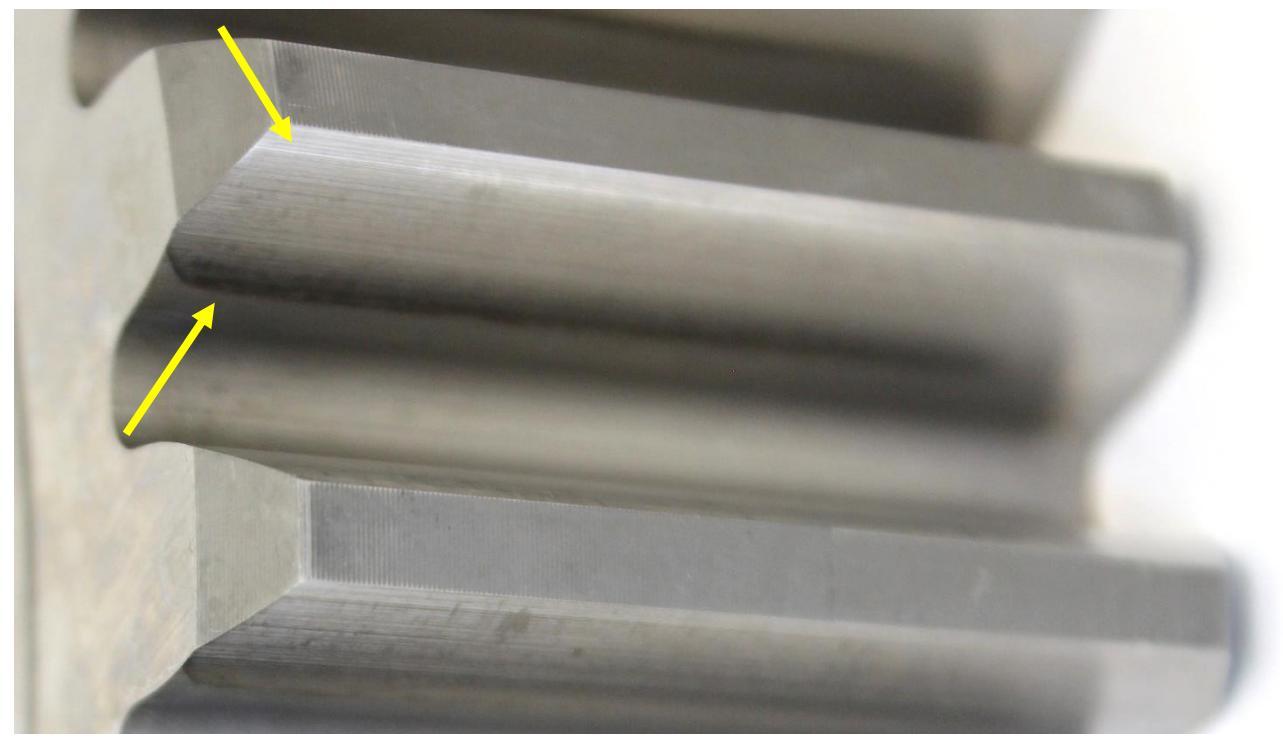
Figure 2: Teeth on undamaged gear: crack development at the end of the contact area, edge at the start of the tip relief

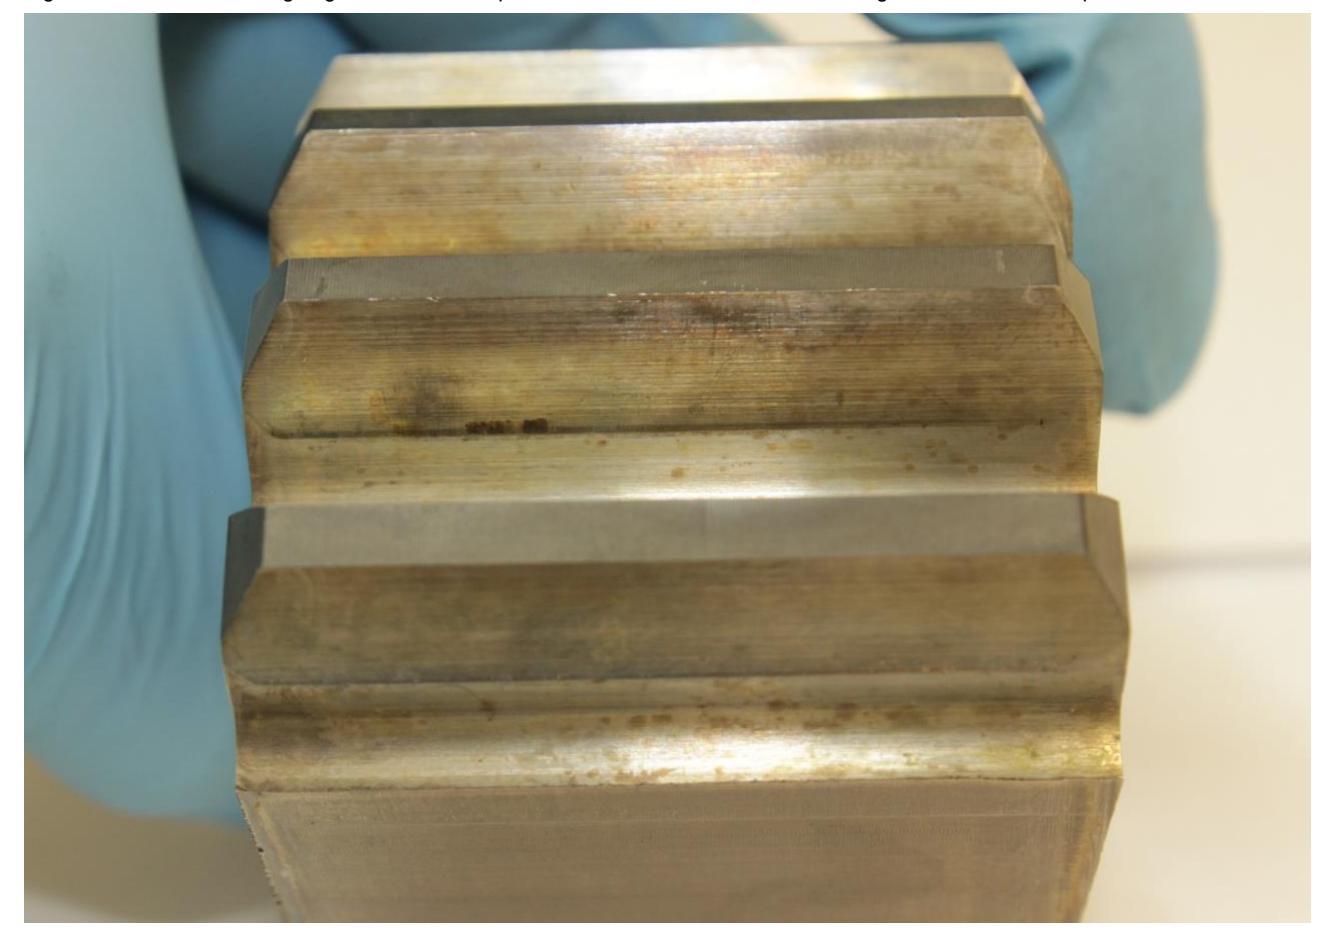
The loaded areas have been darked due to remnants of previously conducted nital etching (Figure 3). This discoloration can be attributed to near-surface structural modifications caused by high loads rather than to grinding burns.

Figure 3: Gear with remnants of nital etching; darker discolorations in the contact area not indicative of grinding burns.

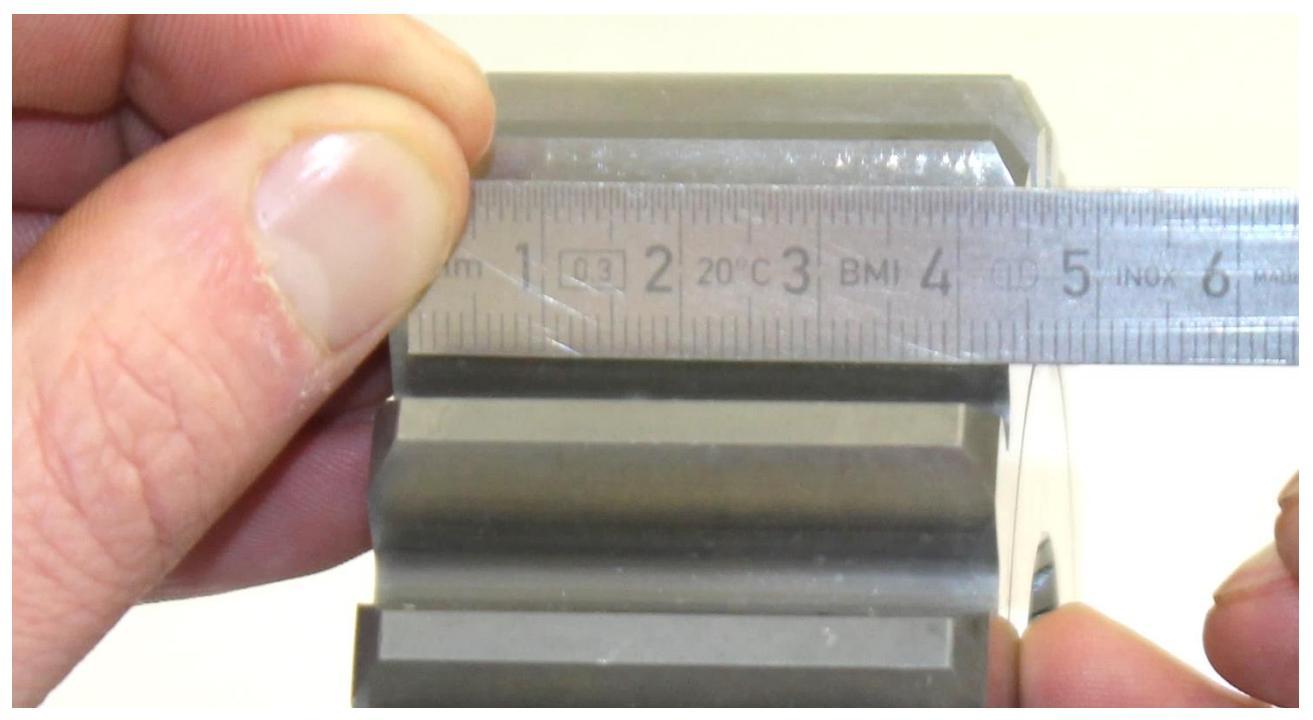
The contact area itself ends abruptly. The width of the contact area at the root corresponds to the width of the meshing gear at the beginning of the tip relief (Figure 4 and

Figure 4: Width of the contact area in area of failure initiation, unbroken tooth: approximately 41.5 mm.

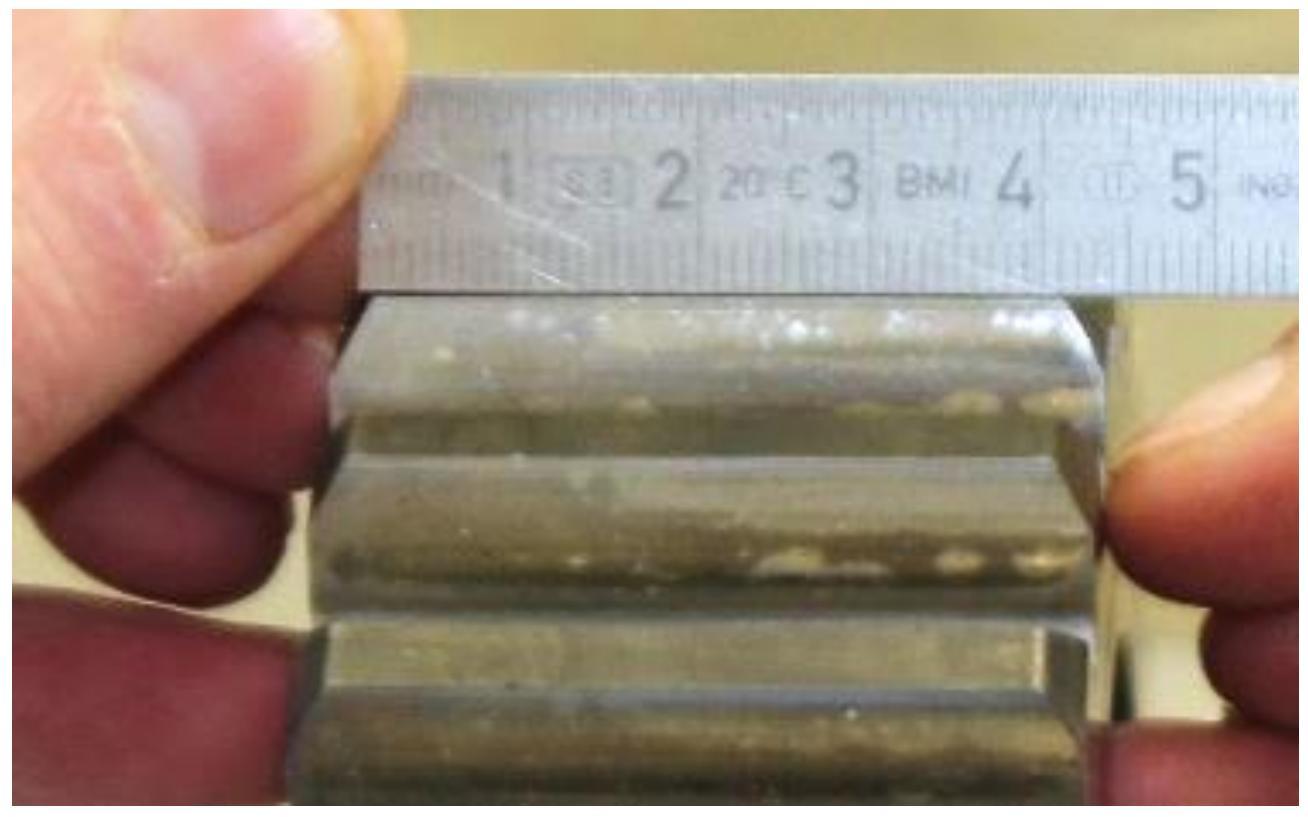
Figure 5). The transition to the tip relief is clearly visible on all teeth and this sudden change increases pressure locally.

Figure 5: Width of the edge at the start of the tip relief, approximately 41.5 mm.

As previously mentioned, the tip relief of the pinions end in a sharp edge and the point of damage corresponds to the location where this edge comes into contact with the wheel. Measured data indicates that the edge

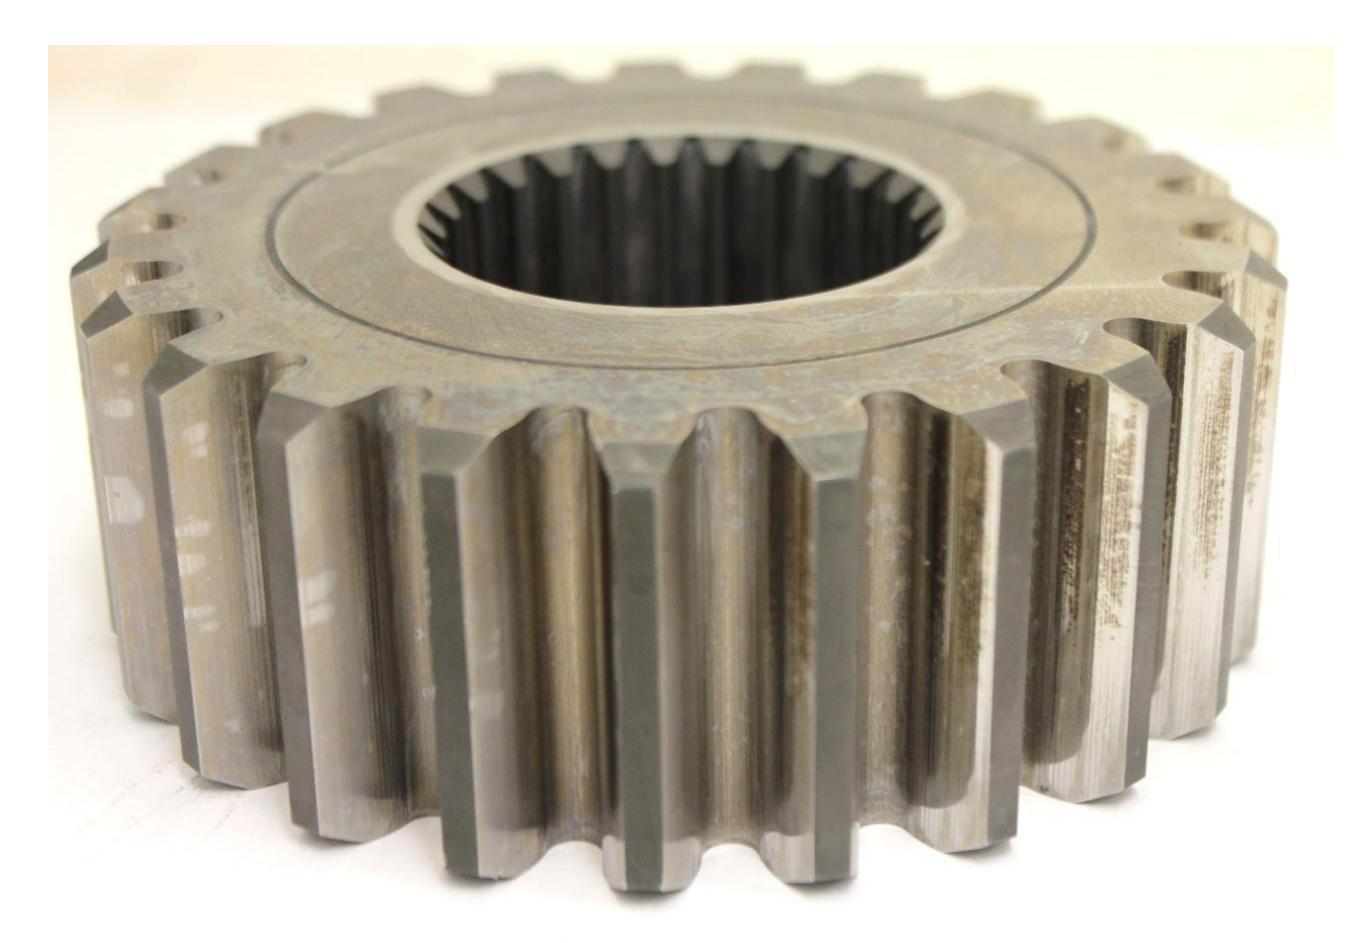
The same beginning wear at the tooth roots and tip relief transition as well as the abruptness of the transition itself were also present on the undamaged gears (Figure 6 and Figure 7). The contact pattern itself also appeared slightly eccentric.

Figure 6: Undamaged gear: slightly eccentric contact pattern, beginning wear near bottom edge of contact area.

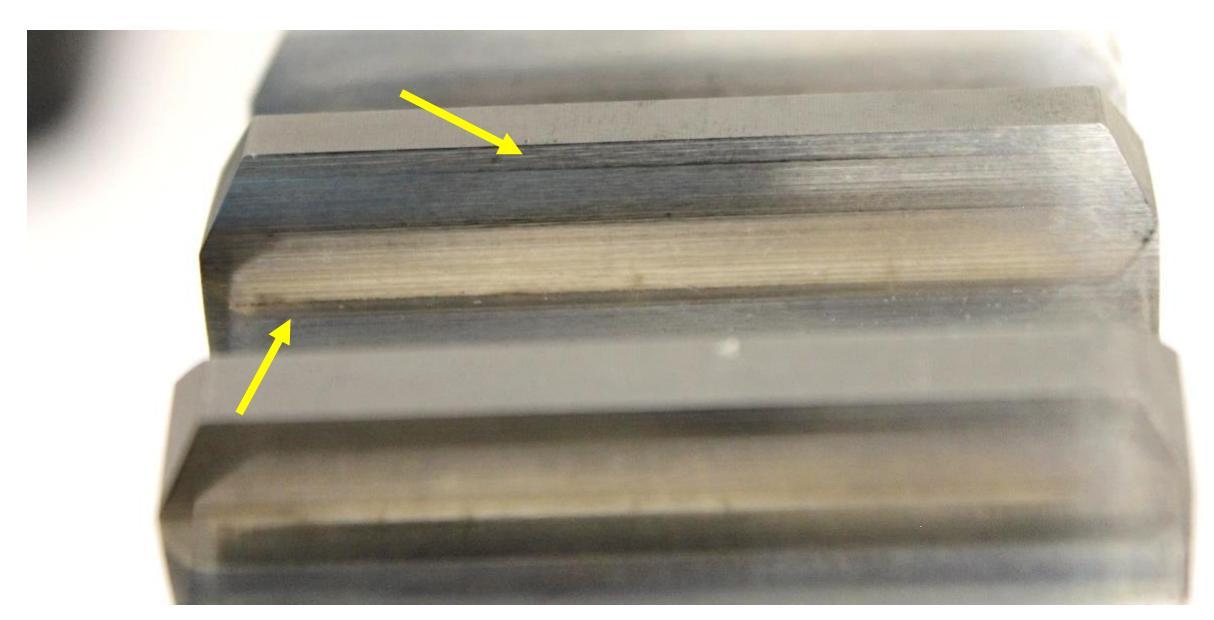
Figure 7: Undamaged gear: beginning wear near the bottom edge of the contact area and edge at the transition to tip relief.

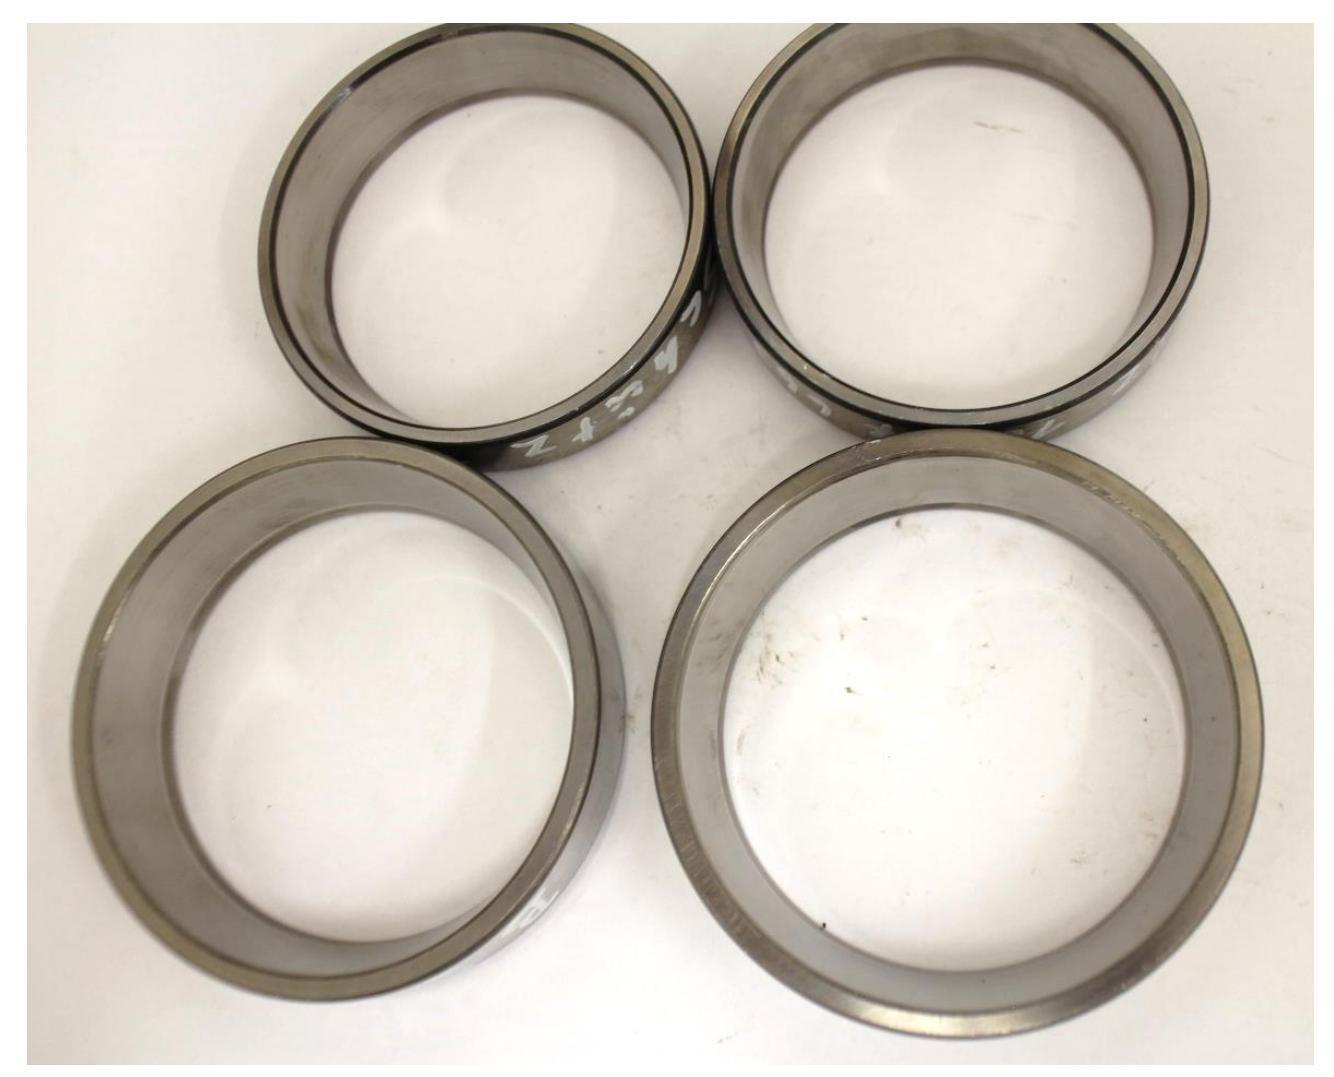
The tapered roller bearings from the two related shafts from undamaged gearboxes were examined. Eccentric damage to gears can be caused when tapered roller bearings are mounted with play instead of preload, which occurs relatively easily during manual installation. However, the appearance of the raceways was consistent with the presence of an axial load (Figure 8). Installation with play rather than preload could therefore be excluded. No damage was found on the bearings and the discoloration on the rollers is consistent with normal tribological reaction layers (Figure 9).

Figure 8: Outer rings of bearings from the related shafts: regular tracks on the raceways indicative of axial loading.

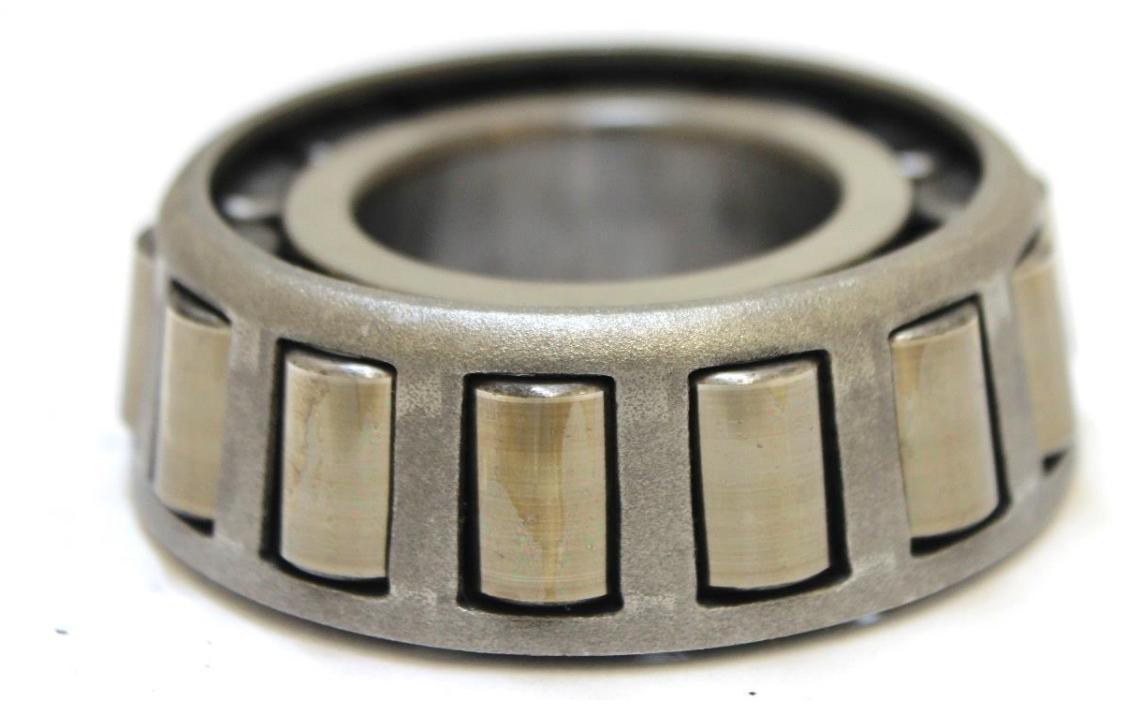
Figure 9: Rollers of one of the bearings, no findings.

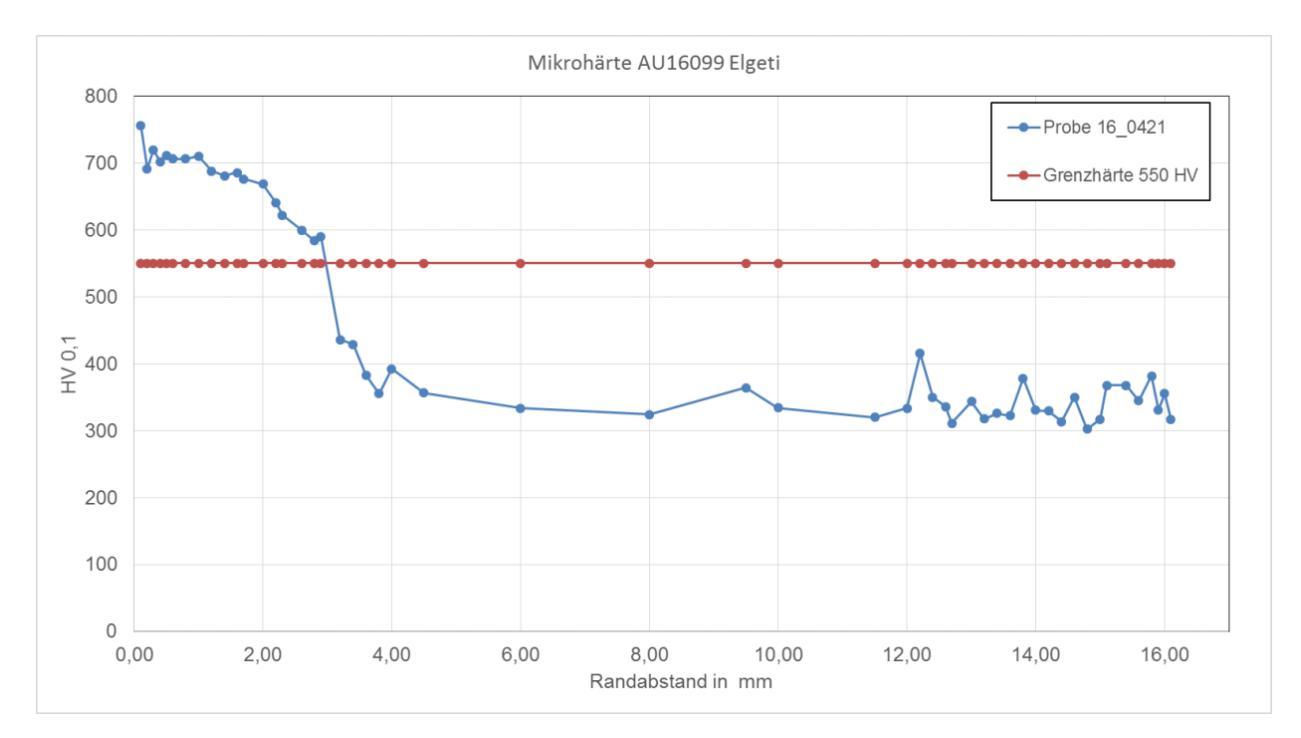
Figure 10: Hardness measurement HV0,1

The Vickers hardness of the gear (HV0,1 and HV1) was measured. Figures 10 and 11 show the results. The hardening depth is therefore 2,4 mm according to HV1.

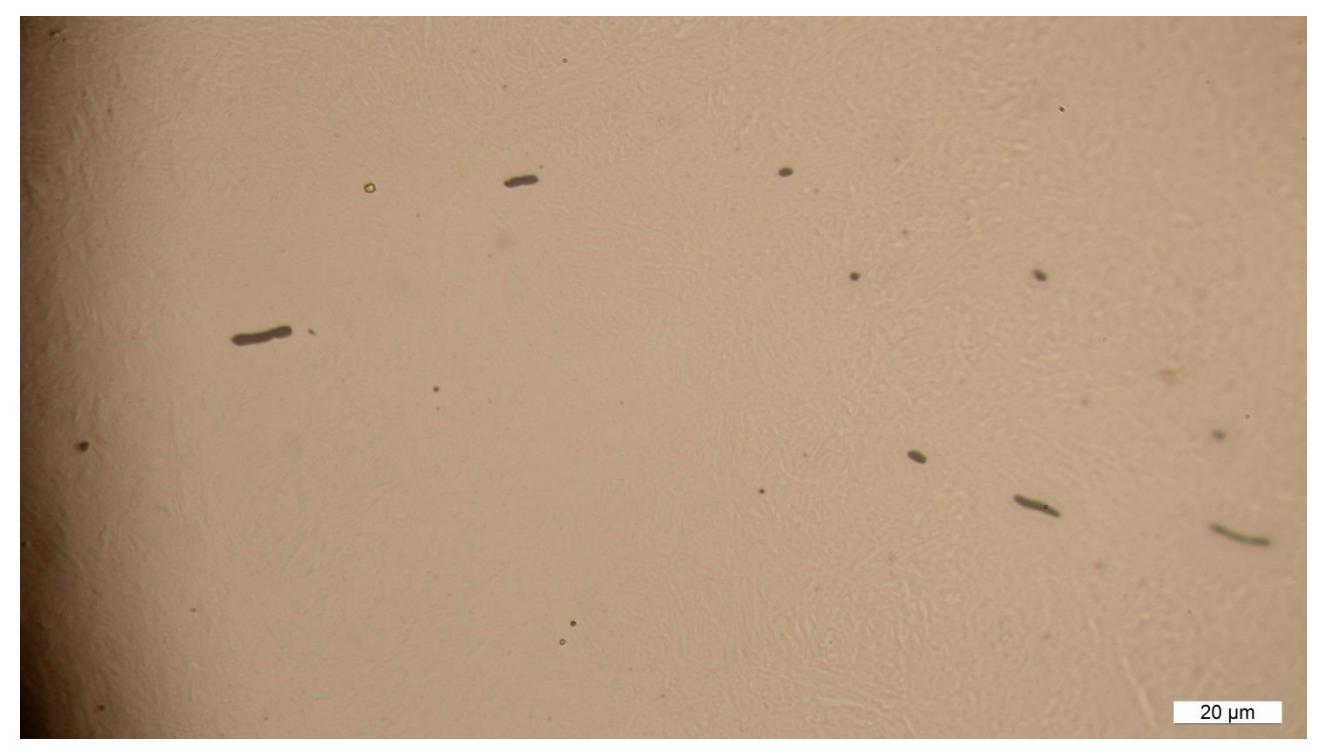
A material inspection was conducted on a sample. Overall, the tempered microstructure was highly pure and regular (Figure 12). The base structure was bainitic (Figure 13) with a martensitic carburized edge microstructure (Figure 14). There was no indication of grinding burns or new areas of hardening.

Figure 12: Only small manganesesulphide inclusions.

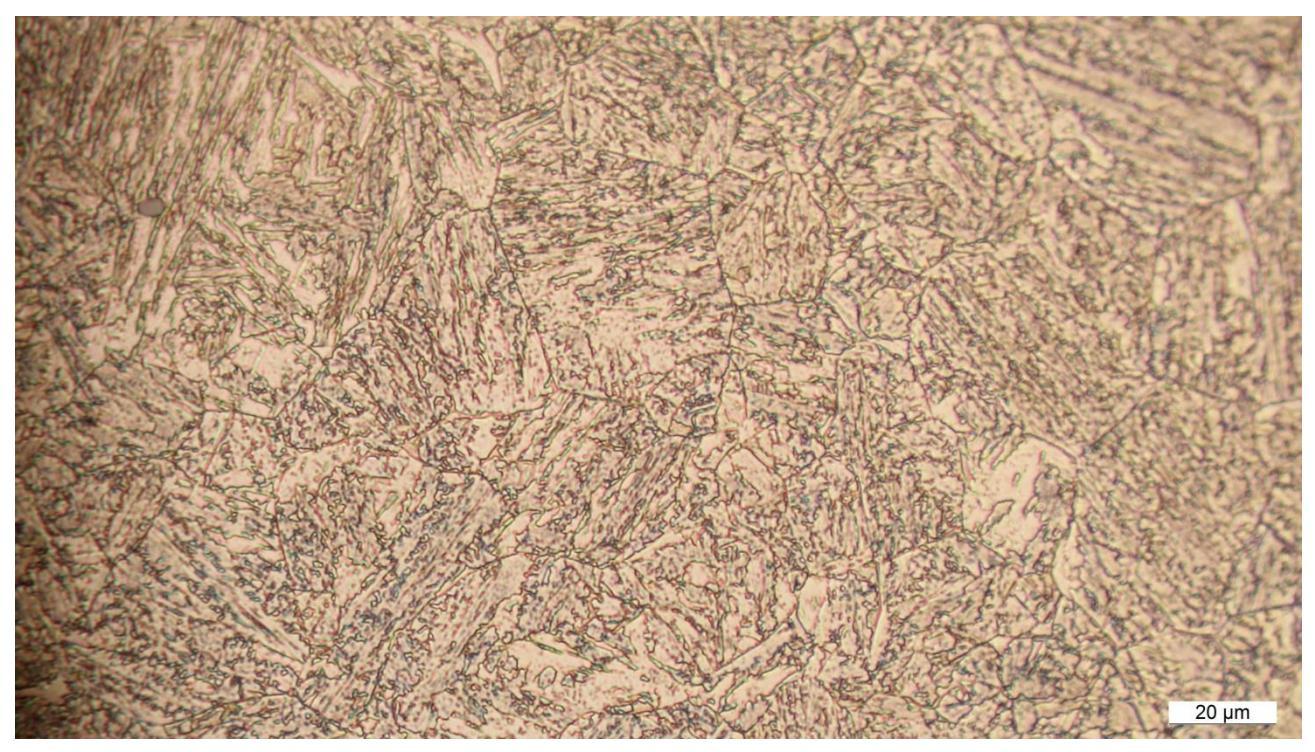
Figure 13: Bainitic base microstructure.

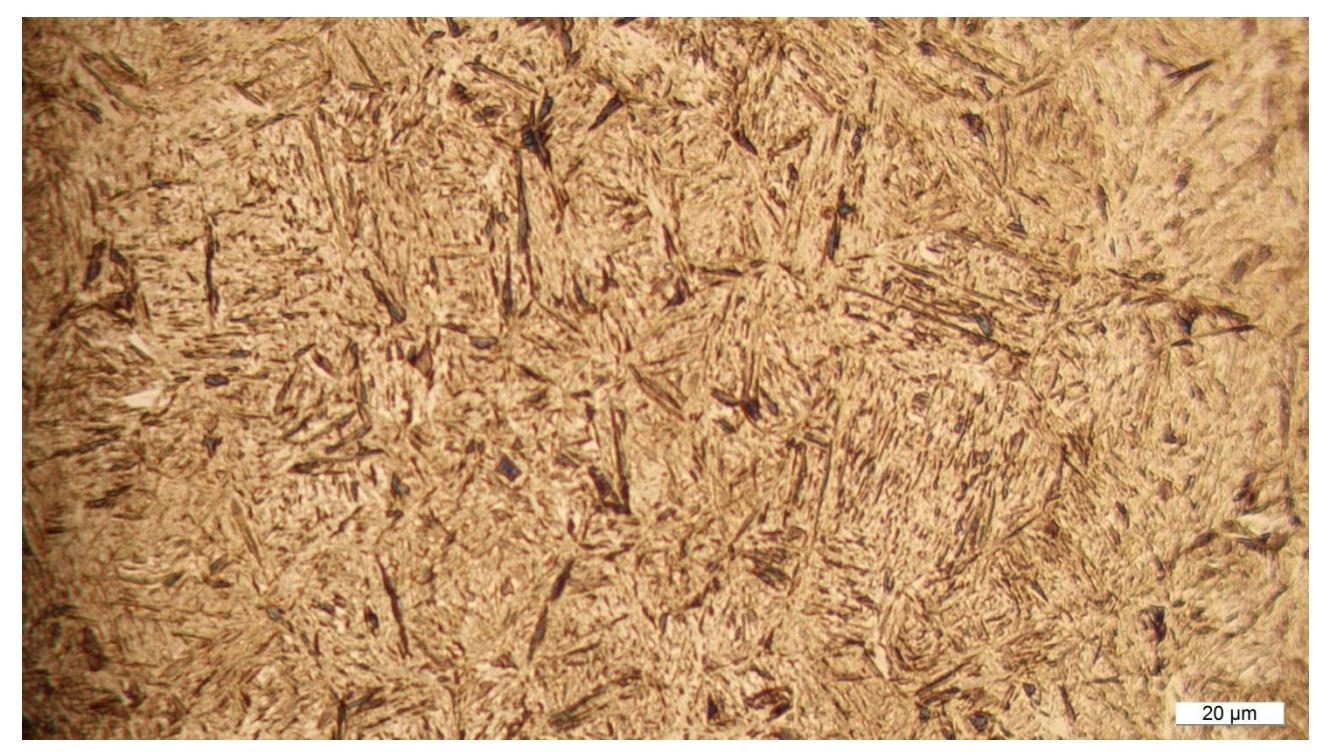
Figure 14: Martensitic edge microstructure with very little remaining austentite (lighter spots).

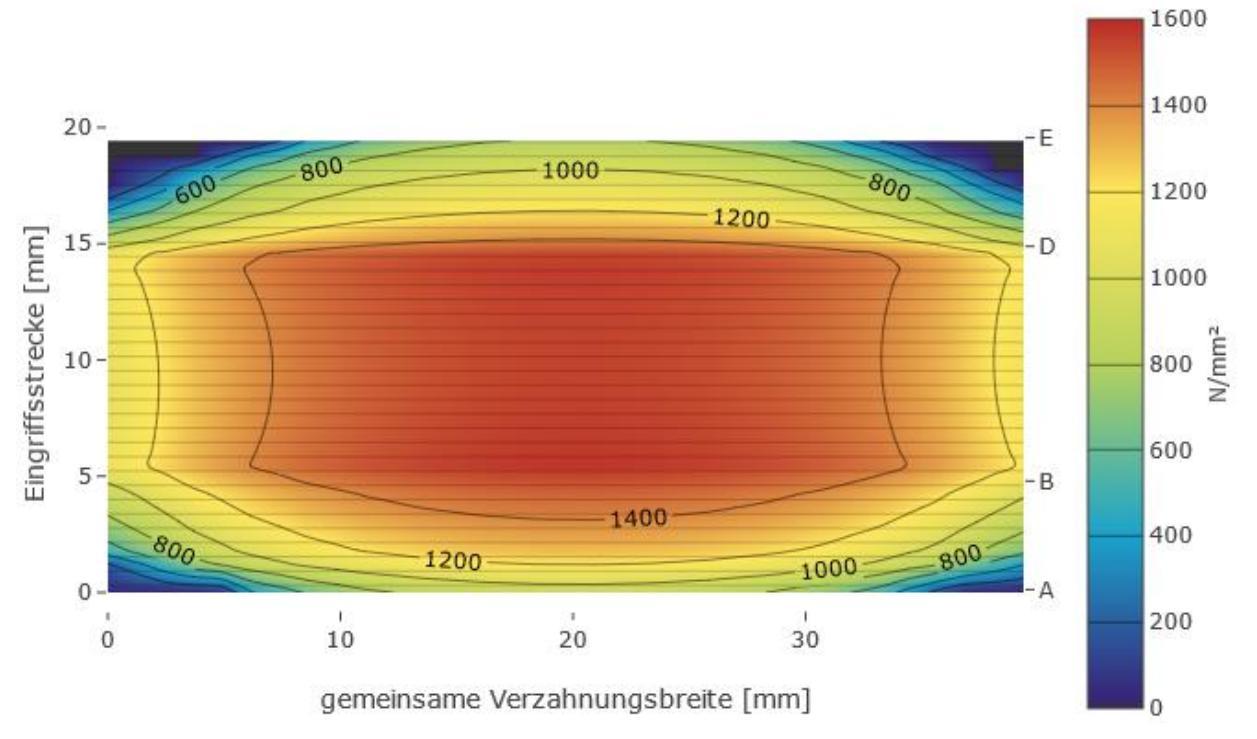
Figure 15: Load case 2, nominal load in second gear

The results depicted in Figures 15 through 17 show well-utilized flanks. It is only in the extreme load case scenario that there is an eccentric contact pattern. Higher pressure is present in the middle section of the flanks, corresponding to the transition between one and two teeth being loaded – i.e. there is an uneven overlap ratio.

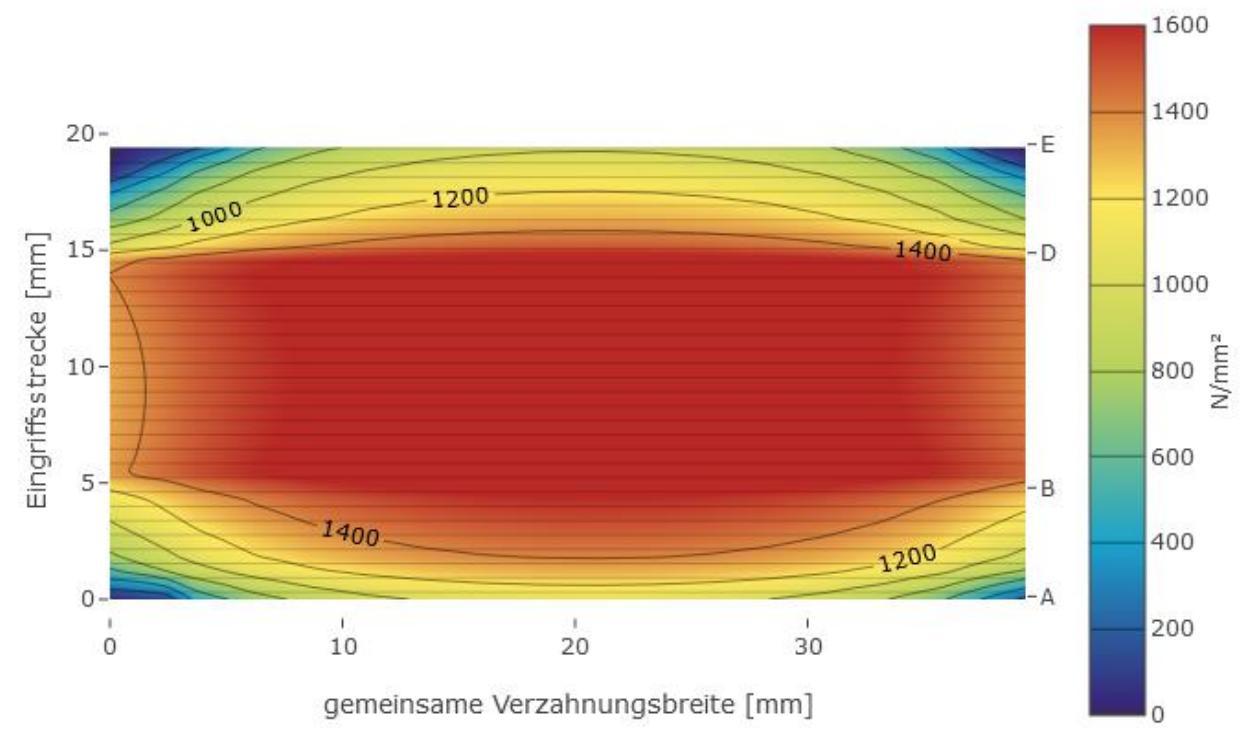
Figure 16: Load case 3, maximum load in second gear: slight eccentricity in the pressure peak beginning to develop.

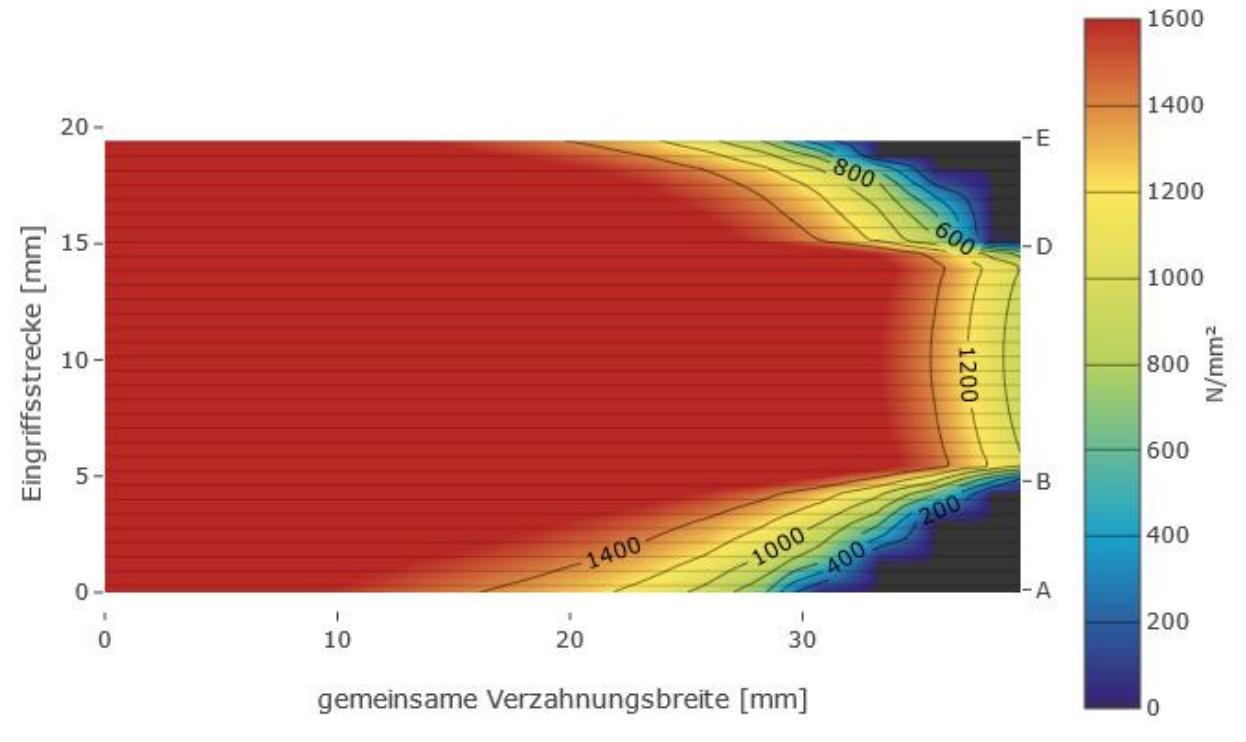
Figure 17: Load case 4, abrupt stop.

Although the overall safety against flank fatigue is smaller than 1.0, the area of peak pressure does not correspond to the origin of the failure. The root cause must therefore be found elsewhere.

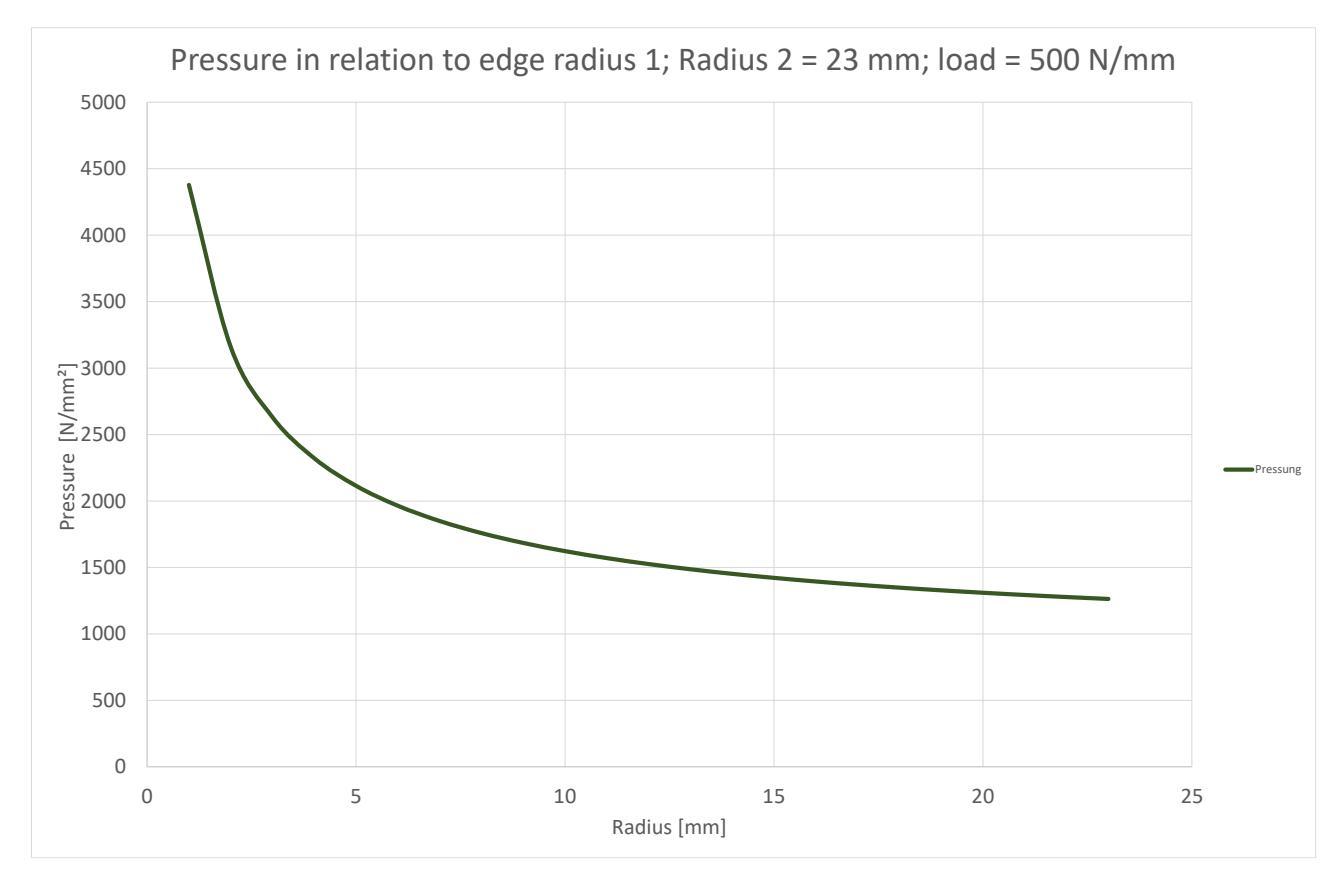
Figure 18: influence of edge radius

radius amounts to values between 1 and 2 mm. Figure 18 shows the influence of such an edge as a function of its radius based on the nominal load and Hertzian Theory. It is clear that the resulting surface pressure can exceed the nominal pressure by several factors, meaning that the results of the simulation can hardly describe the conditions in this specific area.
