Case Study: Gearing Damage

Hagen Elgeti September 2021

1 Background

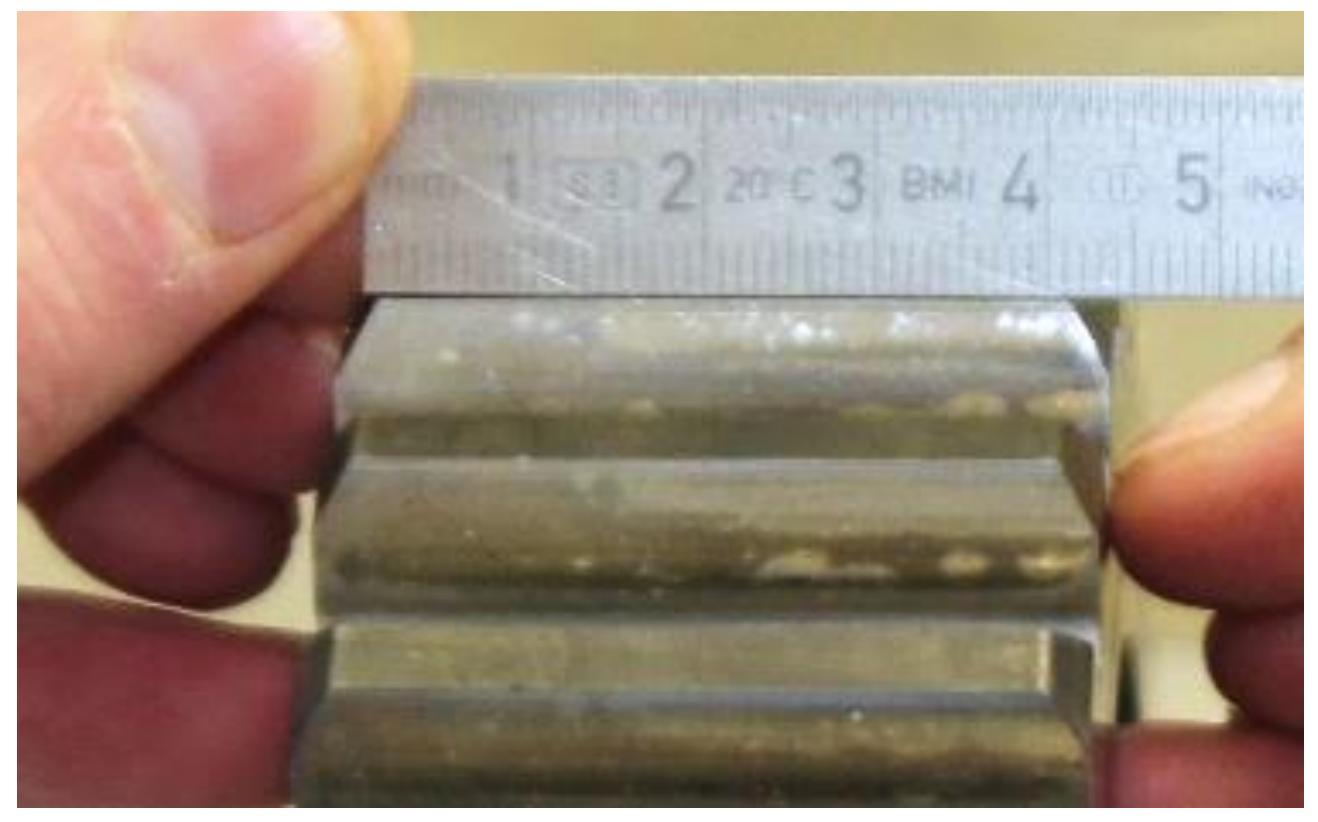
Several damaged gears were received. The most obvious damage was one to two broken teeth due to fatigue fractures. The cracks originated at the bottom of the loaded area of the flank, indicating the presence of high loads. This area of the tooth also experiences the greatest sliding movement which further increased the loads. The point of origin was only slightly eccentric, indicating that no significant misalignment was present (Figure 1). On the undamaged teeth, cracks were also beginning to develop in the same area (Figure 2).

The contact area itself ends abruptly. The width of the contact area at the root corresponds to the width of the meshing gear at the beginning of the tip relief (Figure 4 and

Figure 5). The transition to the tip relief is clearly visible on all teeth and this sudden change increases pressure locally.
